| Audit - Photos Report | | | |
| Factory Name | Dingzhou Weitai fitness equipment Co.,Ltd | Audit type | Full monitoring |
| Customer | amfori BSCI | Report number | CH_BUCHEL_17 |

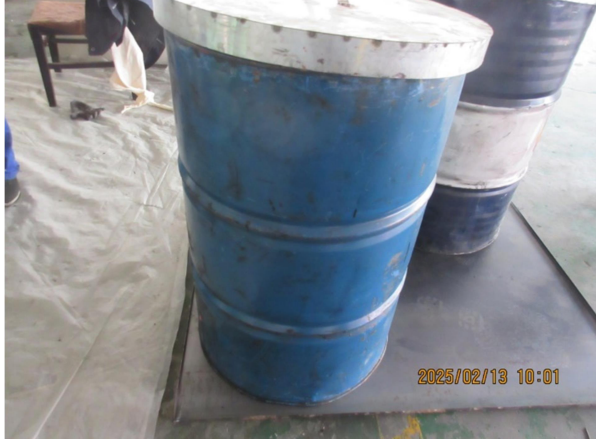
| Comments: EIA Approval | Comments: Pollution Discharge registration | Comments: NC 7.7 No label on chemical container |

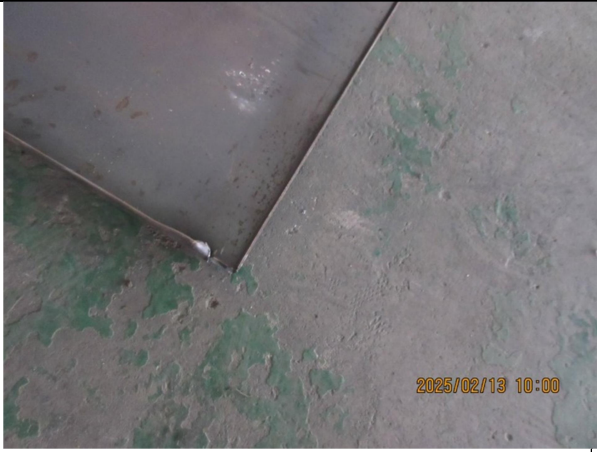
| Comments: NC 7.7 The chemical secondary container was broken | Comments: NC 7.7 The chemical secondary container was broken | Comments: NC7.9 No warning sign such as "Caution Electricity" |

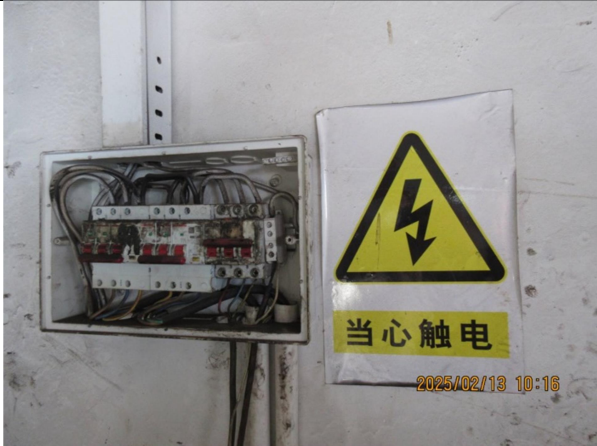
| Comments: NC7.13 No safety cover on the electrical panel | Comments: NC5.5 Social insurance was not cover all employees | Comments: NA |
