实车检测 评估报告

268 V
Vehicle Inspection
Assessment Report

Brand model: Chang an UNI-K 2.0T all-wheel drive Excellence, 2021

Report date: 2024-12-23

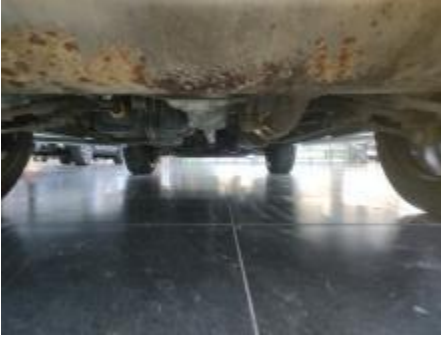
Body floor: restricted and not inspectable
