实车检测 评估报告

268 V
Vehicle Inspection
Assessment Report

Brand model: Chang an UNI-K 2.0T all-wheel drive Excellence, 2021

Report date: 2024-12-23

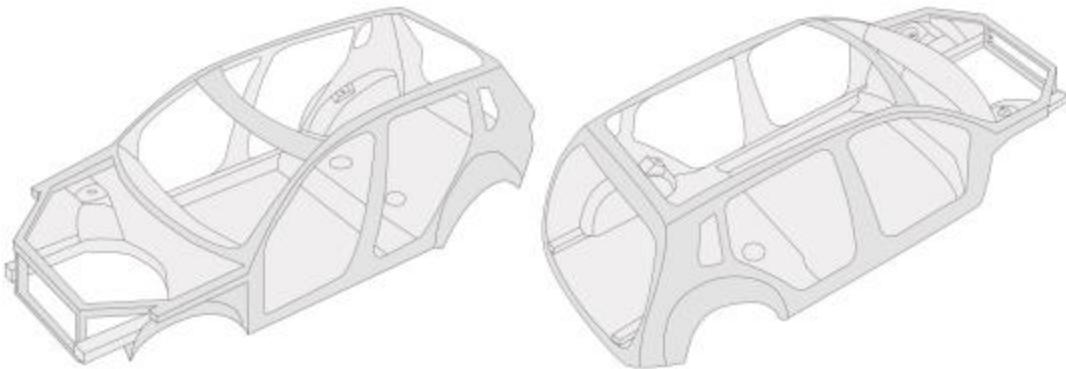
There were 54 accident detection, 0 abnormality, and 0 major accident abnormality

✓ Front fence (firewall)	No trace of accident	✓ roof	No trace of accident
✓ Left roof edge	No trace of accident	✓ Right roof edge	No trace of accident
✓ Non-detachable water tank frame	No trace of accident	✓ Detachable water tank frame	No trace of accident
✓ Left front longitudinal beam	No trace of accident	✓ Right front longitudinal beam	No trace of accident
✓ Left rear longitudinal beam	No trace of accident	✓ Right rear longitudinal beam	No trace of accident
✓ Left front longitudinal beam connection plate	No trace of accident	✓ Right front longitudinal beam connection plate	No trace of accident
✓ Left rear longitudinal beam connection plate	No trace of accident	✓ Right rear longitudinal beam connection plate	No trace of accident
✓ Left front shock absorber seat	No accident traces	✓ Right front shock absorber seat	No trace of accident
